STATE OF HAWAII
DEPARTMENT OF LAND AND NATURAL RESOURCES
COMMISSION ON WATER RESOURCE MANAGEMENT
Stream Protection and Management Branch

FIELD INVESTIGATION REPORT

FI2008102702 (East Maui, Honopou IIFS Site B)

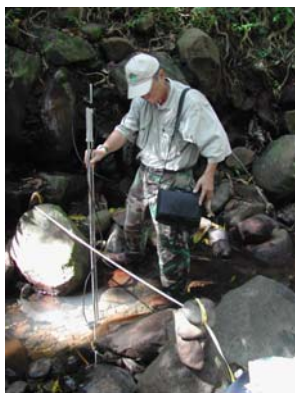
20081027004.JPG

Image Listing: (Attach PDF of image contact sheet) <table border="0"> <thead> <tr> <th><u>File Name:</u></th> <th><u>Brief Description:</u></th> </tr> </thead> <tbody> <tr> <td>20081027004</td> <td>Ed Sakoda conducting flow measurement on Honopou Stream.</td> </tr> <tr> <td>20081027005</td> <td>Staff crew conducting flow measurement on Honopou Stream.</td> </tr> <tr> <td>20081027007</td> <td>Chui Ling Cheng recording flow measurement on Honopou Stream.</td> </tr> <tr> <td>20081027009</td> <td>Gage pool and concrete wall on Honopou Stream.</td> </tr> <tr> <td>20081027010</td> <td>Gage pool and concrete wall on Honopou Stream.</td> </tr> <tr> <td>20081027011</td> <td>IIFS Site B on Honopou Stream.</td> </tr> </tbody> </table>				<u>File Name:</u>	<u>Brief Description:</u>	20081027004	Ed Sakoda conducting flow measurement on Honopou Stream.	20081027005	Staff crew conducting flow measurement on Honopou Stream.	20081027007	Chui Ling Cheng recording flow measurement on Honopou Stream.	20081027009	Gage pool and concrete wall on Honopou Stream.	20081027010	Gage pool and concrete wall on Honopou Stream.	20081027011	IIFS Site B on Honopou Stream.
